SERVICE BULLETIN

M-1185 February 20, 2006

FUEL INJECTOR/CALIBRATION CHANGES FOR 2006 1450cc BIG TWINS

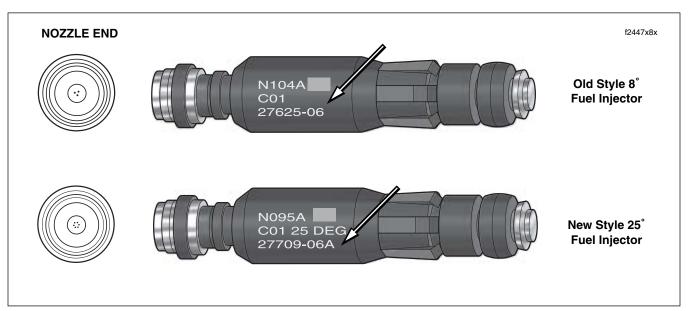
Figure 1. Fuel Injector Part Numbers

Due to changes in the manufacturing process, the part number of the 25° angle cone spray fuel injector is changing from 27709-06 to 27709-06A. This fuel injector also will be stamped with the words "25 DEG" for easy identification. See Figure 1.

If the part numbers on the fuel injectors are rubbed off or otherwise unreadable, count the number of orifices or holes in the injector nozzle. The 8° angle cone spray fuel injector has just three holes, while the 25° has six. See NOZZLE END in Figure 1.

Always replace <u>both</u> 8° angle cone spray fuel injectors on affected motorcycles. Never mix 8° and 25° fuel injectors on the same motorcycle.
