SERVICE BULLETIN

M1450: Milwaukee-Eight Equipped Vehicles - Loss of Power or High Engine Braking

2017-11-15

M1450

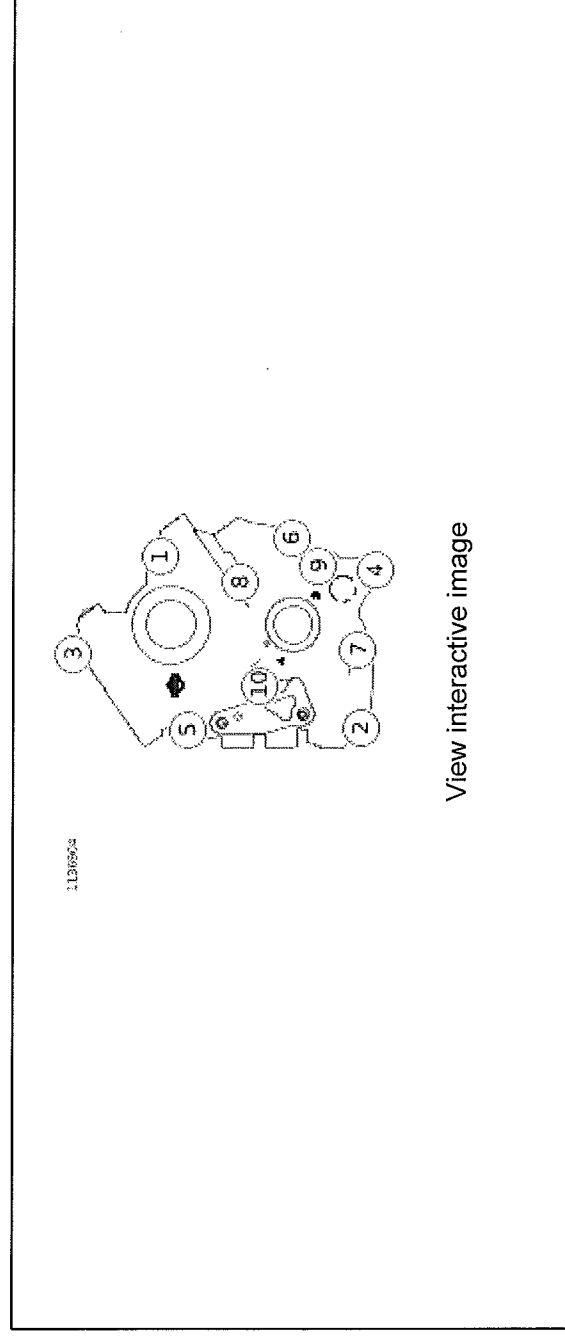
Figure 1. Cam Support Plate Tightening Sequence

2017 and 2018 model motorcycles equipped with a Milwaukee-Eight™ engine can experience a condition known as sumping during extended periods at high rpm or under heavy engine load.

Sumping is when an excessive amount of oil is suspended in the engine crankcase and the flywheel must travel through the oil, resulting in loss of power or a high degree of engine braking and potential engine component damage with extended use under these conditions.

1. Install cam support plate. See the service manual.
2. **Refer to Figure 1.** Follow modified tightening sequence.

Torque: 10.4–12.7 N·m (92–112 in-lbs)

- a. Tighten screws 1–6.
- b. Rotate crankshaft 360°.
- c. Tighten screws 7–10.
